Shorted Diodes? Diode Overheating, Charring, or Non-Obvious Failure Causes?

Diode Failure Symptoms: Shorted, Thermal Runaway, Overheated, Charred, No Mechanical Integrity, No Obvious Symptoms.

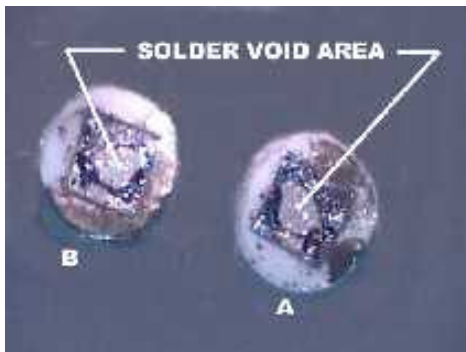
This set of photos illustrates a very common situation when a diode is pried open. The crater-like areas in the center and right-hand photos are solder voids. The black areas are the silicon die.

LARGE VOID AREA REVEALED IN THE SOLDER LAYER

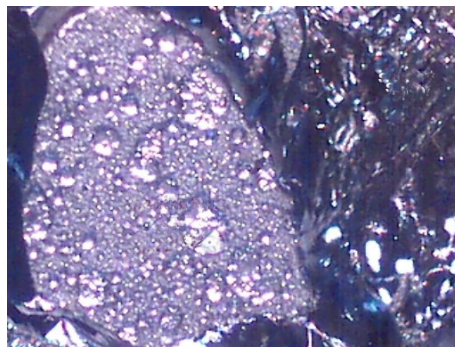
SECTION B

NUMEROUS SOLDER VOIDS CAN CLEARLY BE SEEN IN THESE CLOSE UPS. These Voids 1) Greatly Weaken The Diode's Mechanical Integrity, 2) Increase The Forward Voltage Drop, and 3) Severely Restrict The Dissipation of Heat From The Die. Restricted Heat Dissipation causes the Diode to Operate at Elevated Temperatures Which Could Lower Its Current Handling and/or Cause Premature Failure.

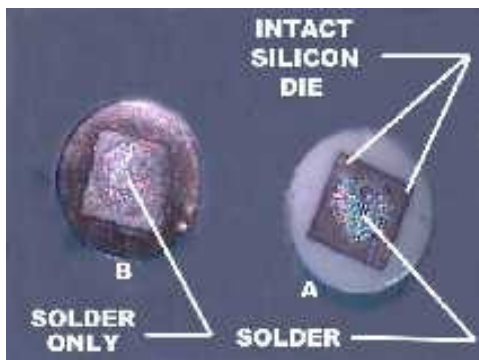
This set of photographs illustrates another common, but much more serious, situation. Here the diode is pried open and separates completely at the die solder layer

**ONLY SOLDER IN SECTION B
 CHIP IS INTACT IN SECTION A
 SOLDER COVERS ~ 50% OF DIE**

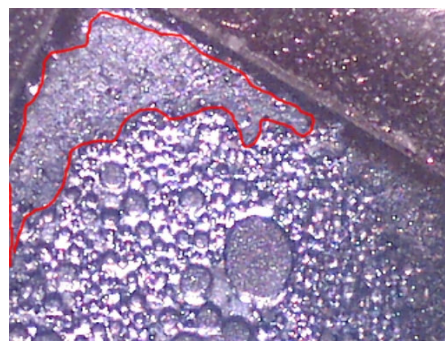
SECTION B - ONLY SOLDER

The Solder Either Failed to Wet And, Hence, Bond to The Die's Surface (Surface Outlined in Red on Section B) or is riddled with voids. As a Result, This Diode Has Absolutely No Mechanical Strength And May Fail On Impact if Dropped or Struck. Additionally, The Thermal Resistance of This Diode is so High that Thermal Runaway is a Certainty.

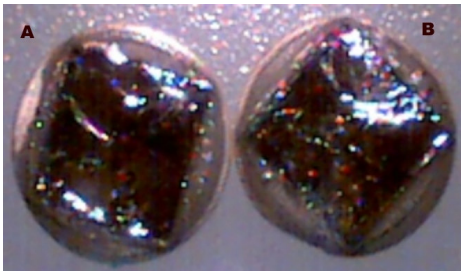
**BREAKS AT SILICON DIE
NO VISIBLE VOIDS.**

DIOTEC utilizes an advanced, computer controlled, vacuum die soldering process, which enables silicon chips to be soldered to metal with **exceptional consistency** and **void free quality**. Thus, DIOTEC diodes and bridge rectifiers have unmatched heat dissipation, cooler junction temperatures, lower leakage currents, and reduced thermal stress. Additionally, the high quality die attachment allows the diodes survive mechanical shock without bond failure, another common problem with most offshore "cheap" diodes.

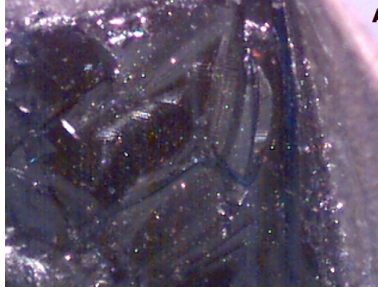
SECTION A

Superior Soldering Results in SUPERIOR MECHANICAL STRENGTH, SUPERB HEAT DISSIPATION, and LOWER FORWARD VOLTAGE DROP
