**DIOTEC ELECTRONICS CORPORATION**  
 18020 HOBART BLVD. UBIT B, GARDENA, CA 90248 USA  
 PH: 310-767-1052 FX: 310-767-7958  
 E-MAIL: support@diotec-usa.com  
 WEB SITE: www.diotec-usa.com

***EVER WONDER WHY SOME DIODES DIE PREMATURELY  
 ..... WITHOUT OBVIOUS CAUSE***

**Most Likely It's The Invisible Killer .... **DIE ATTACH SOLDER VOIDS****

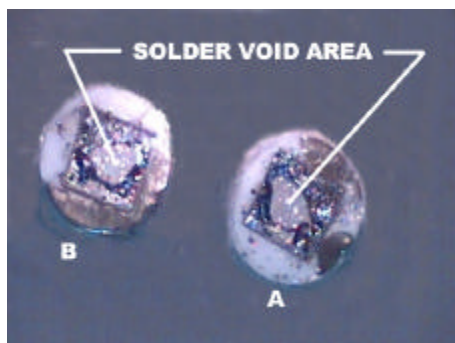
This set of photos illustrates a very common situation when a diode is pried open. The **crater-like areas** in the center and right-hand photos are **solder voids**. The black areas are the silicon die.

**LARGE VOID AREA REVEALED IN THE SOLDER LAYER**

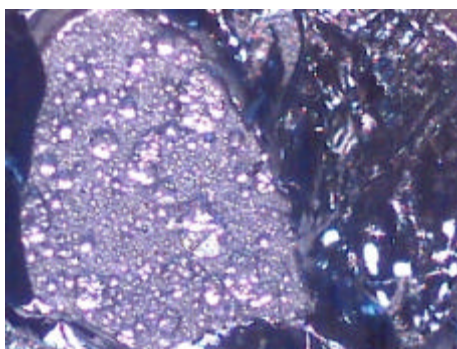
**SECTION B**

**NUMEROUS SOLDER VOIDS CAN CLEARLY BE SEEN IN THESE CLOSE UPS.** These Voids 1) Greatly Weaken The Diode's Mechanical Integrity, 2) Increase The Forward Voltage Drop, and 3) **Severely Restrict The Dissipation of Heat From The Die.** Restricted Heat Dissipation causes the Diode to Operate at Elevated Temperatures Which Could Lower Its Current Handling and/or Cause Premature Failure.

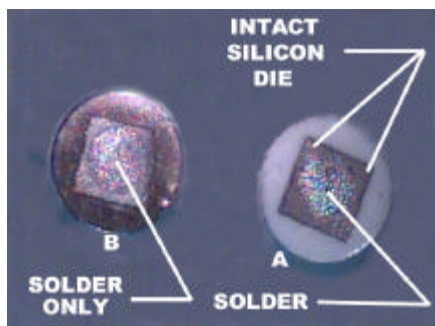
This set of photographs illustrates another common, but much more serious, situation. Here the diode is pried open and separates completely at the die solder layer

**ONLY SOLDER IN SECTION B  
 CHIP IS INTACT IN SECTION A  
 SOLDER COVERS ~ 50% OF DIE**

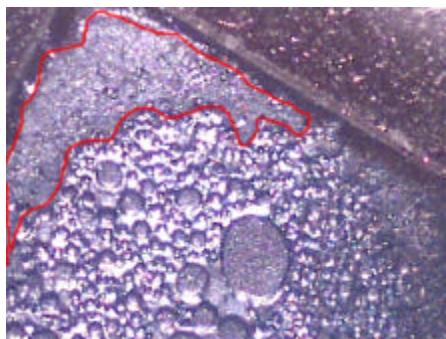
**SECTION B - ONLY SOLDER**

The Solder Either Failed to Wet And, Hence, Bond to The Die's Surface (Surface Outlined in Red on Section B) or is riddled with voids. As a Result, This Diode Has Absolutely No Mechanical Strength And May Fail On Impact if dropped or Struck. Additionally, The Thermal Resistance of This Diode is so High that Thermal Runaway is a Certainty.

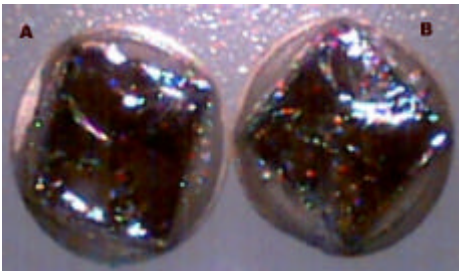
*This is the High Quality DIOTEC difference.*

**BREAKS AT SILICON DIE  
NO VISIBLE VOIDS.**

DIOTEC utilizes an advanced, computer controlled, vacuum die soldering process, which enables silicon chips to be soldered to metal with **exceptional consistency** and **void free quality**. Thus, DIOTEC diodes and bridge rectifiers have unmatched heat dissipation, cooler junction temperatures, lower leakage currents, and reduced thermal stress. Additionally, the high quality die attachment allows the diodes survive mechanical shock without bond failure, another common problem with most offshore "cheap" diodes.

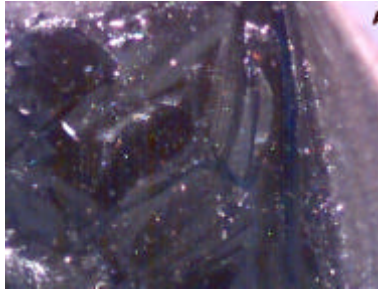
**SECTION A**

**Superior Soldering Results in SUPERIOR MECHANICAL STRENGTH, SUPERB HEAT DISSIPATION, and LOWER FORWARD VOLTAGE DROP**
